Fort Monroe Historic Viewsheds

Megan Weaver Tooker, Adam Smith, Chris Cochran, and
Chelsea Pogorelac

Final report

Prepared for DPW-Environmental Branch
Fort Monroe
318 Cornog Lane, Bldg 28
Fort Monroe, VA 23651

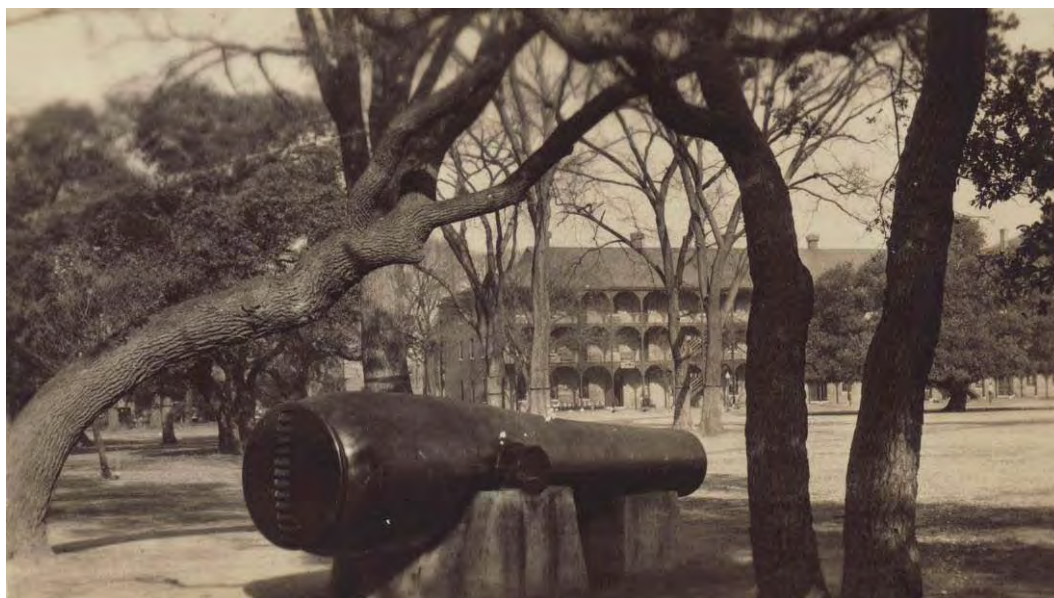
Figure 13. Lincoln Gun, post 1900 – exact date unknown (Fort Monroe Cultural Resources).

to the Carolinas, providing shelter and supplies to Union ships participating in the blockade. In March 1861, Fort Monroe received a prototype 15 inch Rodman smooth bore gun, named “The Lincoln Gun,” for testing. The gun remains today as a prominent remnant of the Civil War at the edge of the parade ground inside Fort Monroe (Figure 13). The bottle shaped barrel is 15 feet and 10 inches in length with its widest diameter at 4 feet. It weighed 49,000 pounds when built.

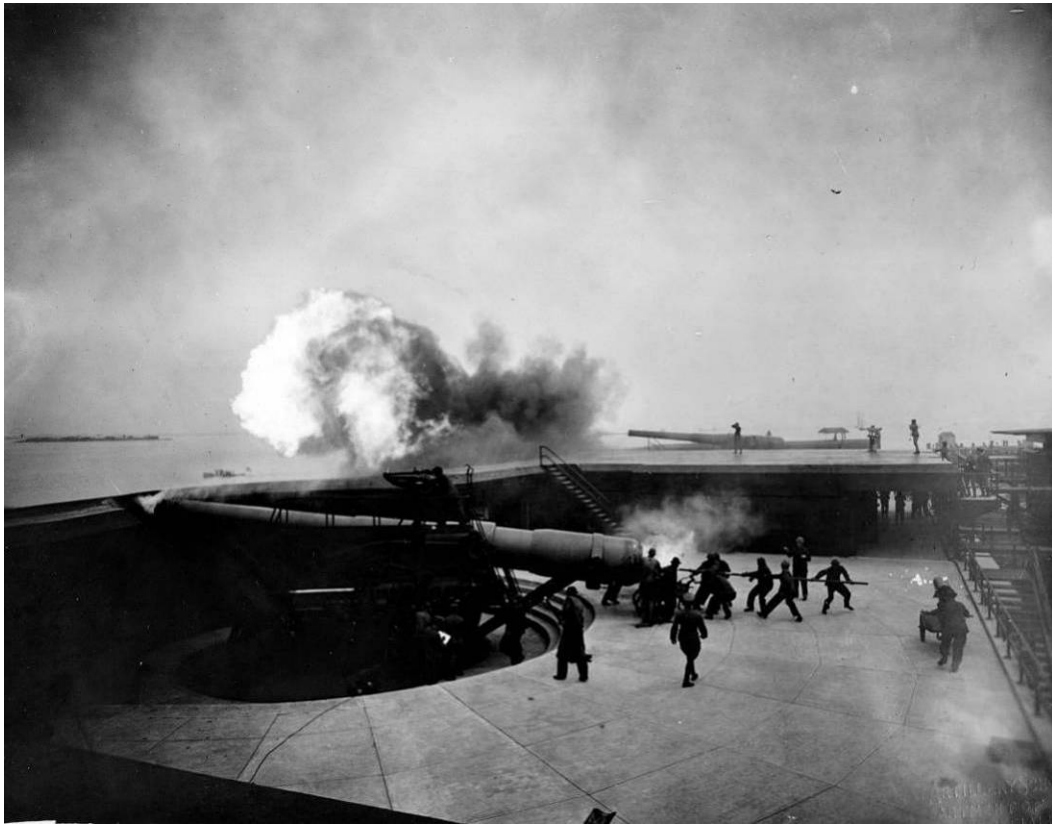
Figure 21. Batteries, 1918 (NARA College Park).

In 1885, President Grover Cleveland convened a board under Secretary of War William Endicott to plan a new system of coastal defense. The Civil War, particularly the Union bombardment of Fort Pulaski with rifled artillery, had demonstrated that the Third System fortifications could not withstand modern weaponry. In 1891 construction began at Fort Monroe on detached batteries of concrete with earthen parapets (Figure 21). Batteries Gatewood, DeRussy, and Church were completed in 1898, Batteries Ruggles and Anderson in 1899, Battery Irwin in 1903, and Battery Parrott in 1906.

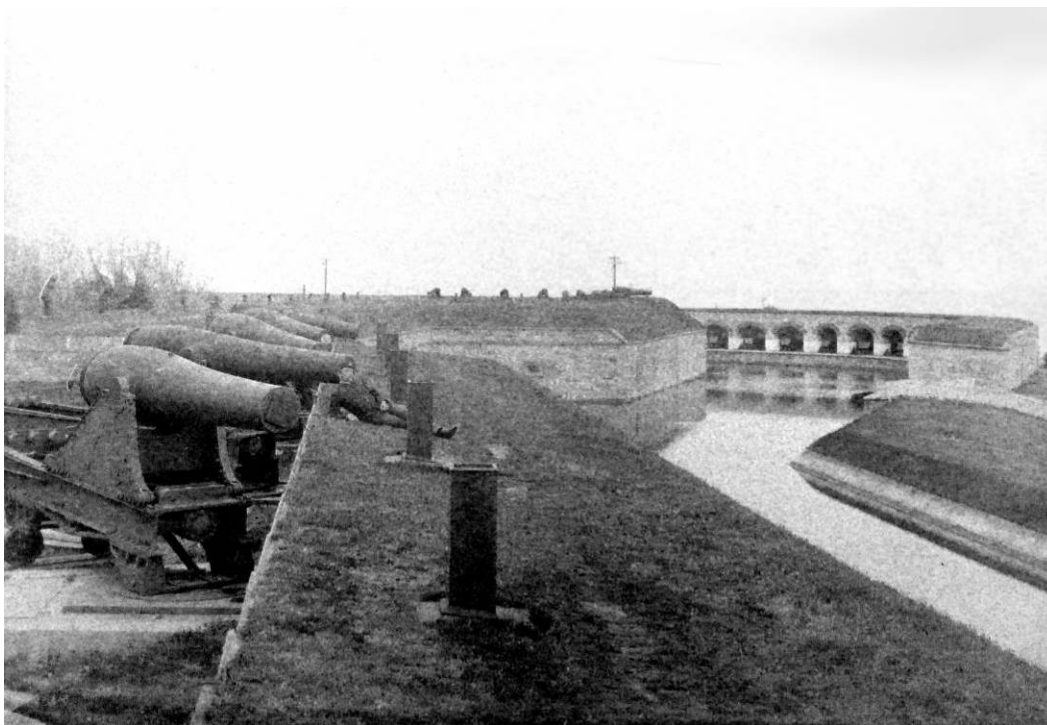
Figure 34. View of guns mounted on fort, date unknown (NARA College Park).

Unfortunately, very few photographs remain of Fort Monroe's military activity. Glancing at the vibrant tourist post cards and photographs it is hard to picture an active Army installation. What few photographs do remain that feature soldiers, generally, show one or more standing behind a battery or posing next to the guns (Figure 33). Very few photographs were found of the views or sightlines from the batteries or out of or from the top of the casemates, which are historically very significant views which speak to the strategic location of Fort Monroe and the defense of the Chesapeake Bay (Figure 34).

After the turn of the century and the construction of the Endicott Period Batteries, the fort, casemates and gun placements were no longer in use due to advancements in battleship construction and the subsequent weapon technology. The 15" Rodman guns situated at the top of the fort were obsolete, replaced by the 10" and 12" disappearing rifles and rapid-fire guns that were mounted on the Endicott Batteries. These advances were echoed by the construction of officers' quarters and hotels between the fort and the harbor permanently obstructing these significant views.

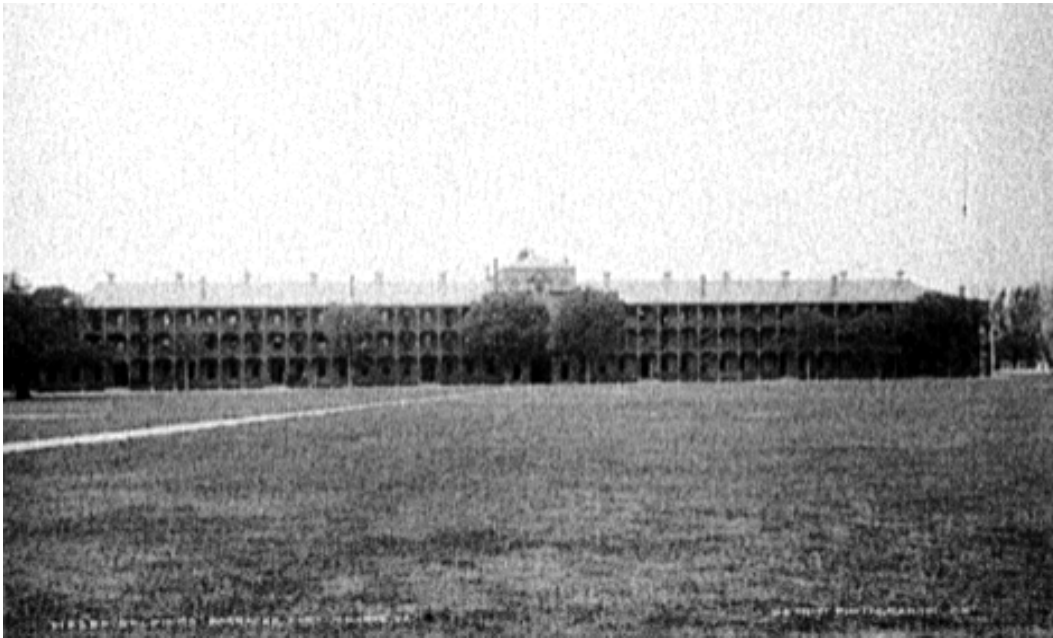
Figure 40. Soldier's Barracks, 1900-1906 (Library of Congress).

The stone fort contains the oldest buildings and viewsheds on Fort Monroe. Around the parade ground and Building 5, barracks built in 1879, are the most highly photographed views. The massive size of Building 5 and the architectural features such as the porches and clock are contrasted with the wide expanse of grassy open space. Some pictures include the picturesque Live Oaks that line the parade field. The parade ground was used for sports, maneuvers, and other activities. Classes in surveying were also held on the parade ground. Historically, parade grounds were the heart of military installations and this is reflected in installation planning and design. The ceremonies and graduations held on the parade ground increases the number of photographs in circulation.

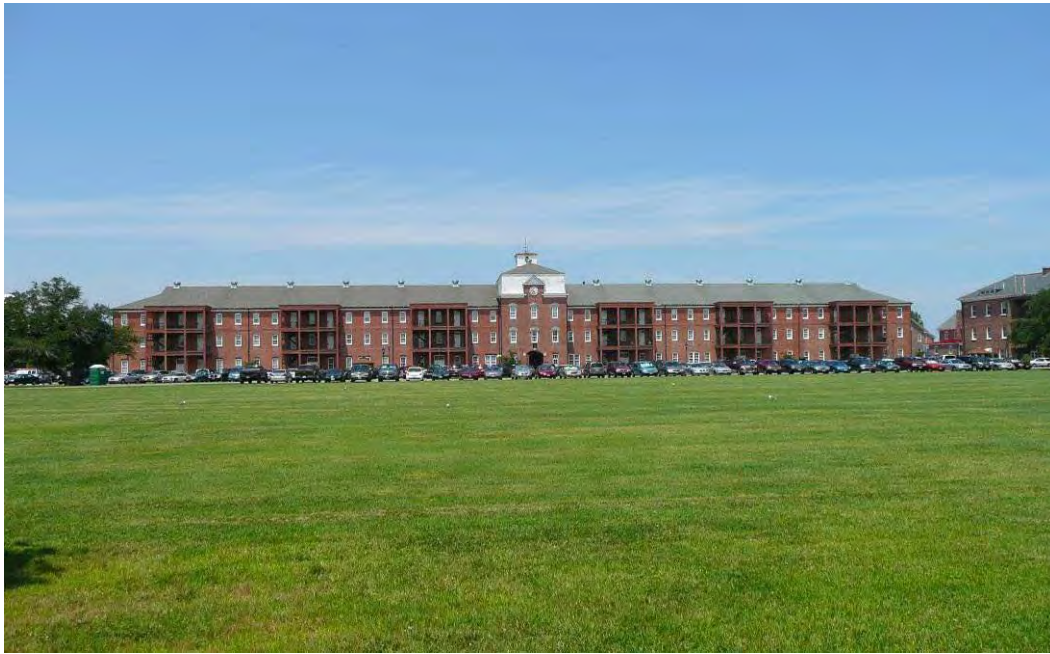
Figure 43. View across Parade Ground toward Building 5, 2009.

Building 5 is currently offices and administration. The building has undergone many architectural modifications over the years. The trees planted along the building have been removed and a parking lot added for employees in the building. The grassy open parade ground has not changed, however some of the mature oaks have not survived.

- Parking lot, smoking structure, portable toilet
- Lack of porches on Building 5, missing architectural details, and condition
- Lack of trees

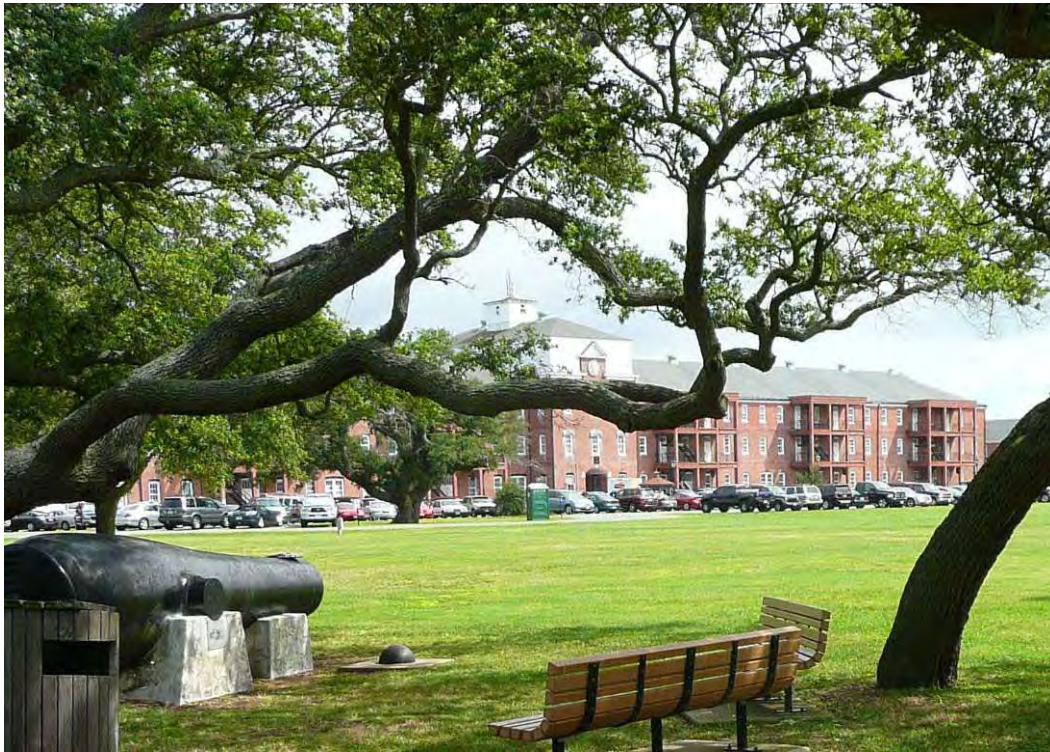
Figure 47. View from cannon toward Building 5, 2009.

This view remains very similar to the historic views in part to the surviving Live Oak trees, Building 5, the Lincoln Gun and the open parade ground. However, a parking lot has been added in front of Building 5, as well as benches, a partially buried cannon ball, signage and a trash can adjacent to the gun.

- Addition of Parking lot, smoking structure, and portable toilet
- Lack of porches on Building 5, missing architectural details, and condition
- Missing a row of trees in front of Building 5

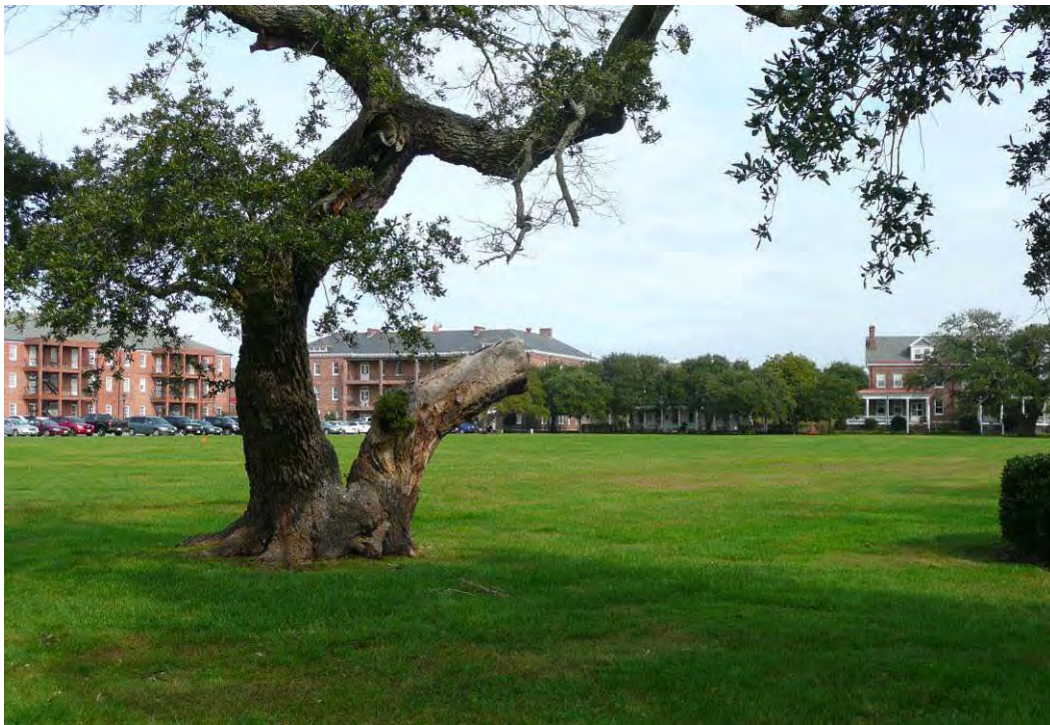
Figure 51. View across parade ground looking east, 2009.

Building 139 is still used as barracks while Building 5 is now administration. A large parking lot has been built in front of Buildings 5 and 139 for employees. The view across the parade ground is still open and unobstructed. The large tree in the foreground is in poor condition.

- Parking lot
- Lack of original cast iron porches on Building 5, replaced porches on Building 139, missing architectural details, and condition
- Lack of trees in front of Building 5

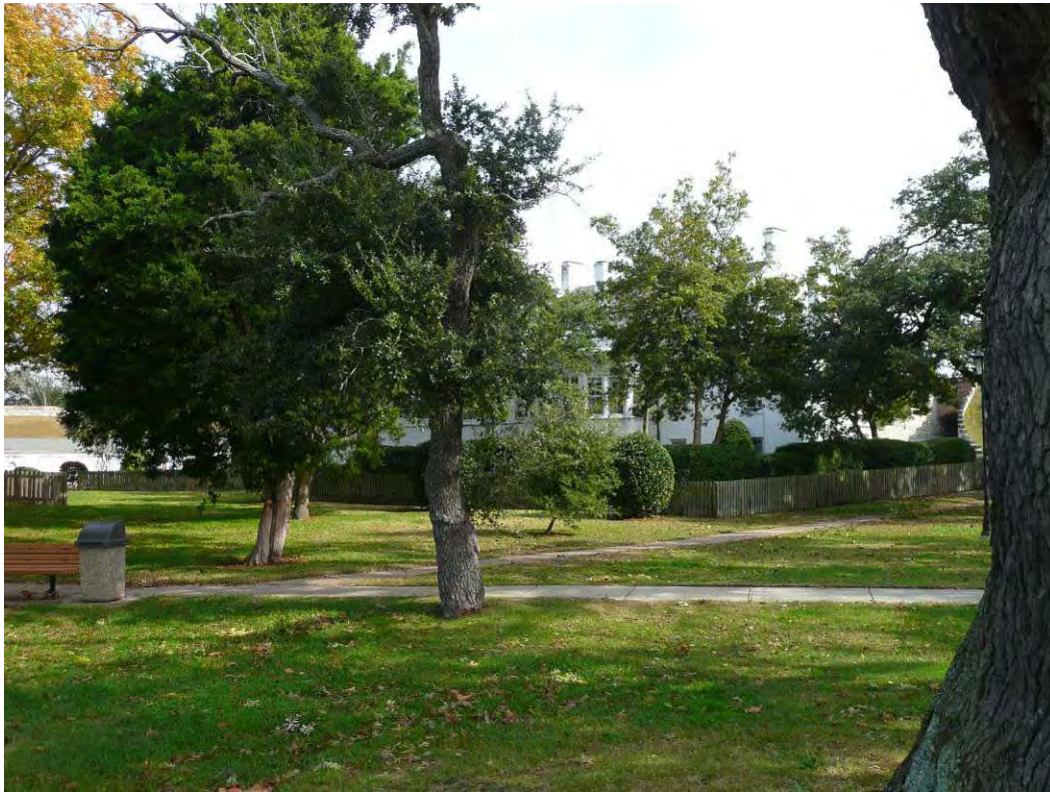
Figure 54. View of rear of Quarters 1, 2009.

Quarters 1 is currently being used as offices for the FMFADA. The garden is smaller today than it was in the past; however it is still surrounded by a wooden fence.

- Missing pergola and pavilion
- Smaller size of garden

- Replacement fence

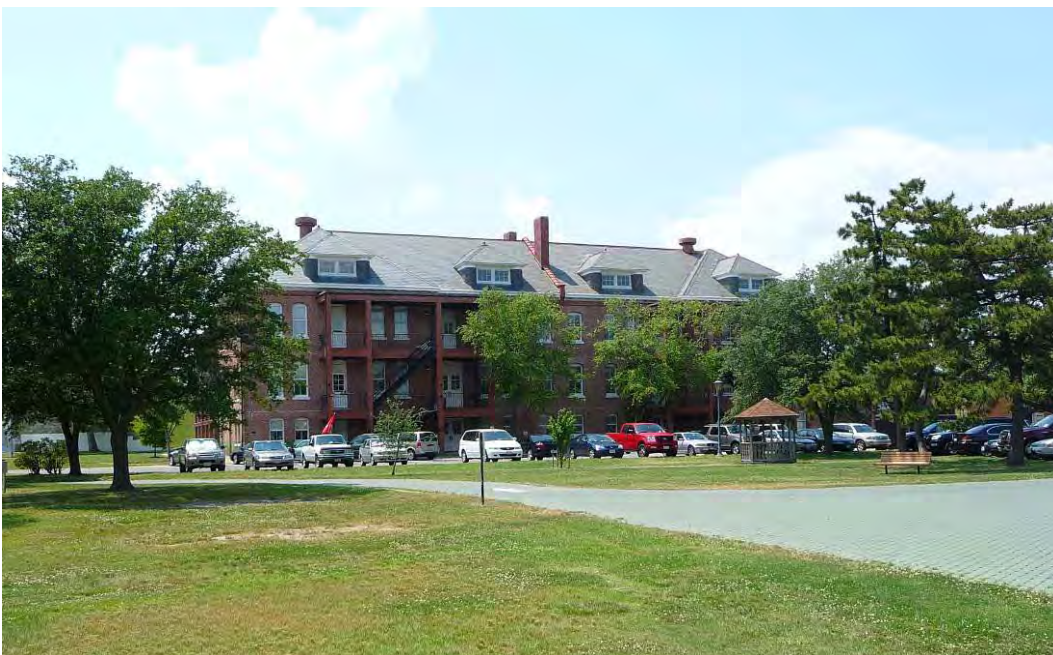
Figure 56. View toward Building 10, 2009.

Building 10 is currently being used for offices and administration. A parking lot has been added between the building and the parade ground for employees with a drive that connects to the parking lot behind Building 5.

- Addition of parking lot, smoking structure, benches, and picnic table
- Lack of original cast iron porches on Building 5, missing architectural details, and condition
- Lack of trees

- Minimize or remove the impact of vehicle parking and non-historic circulation patterns
- Remove smoking structure
- Replace historic porches

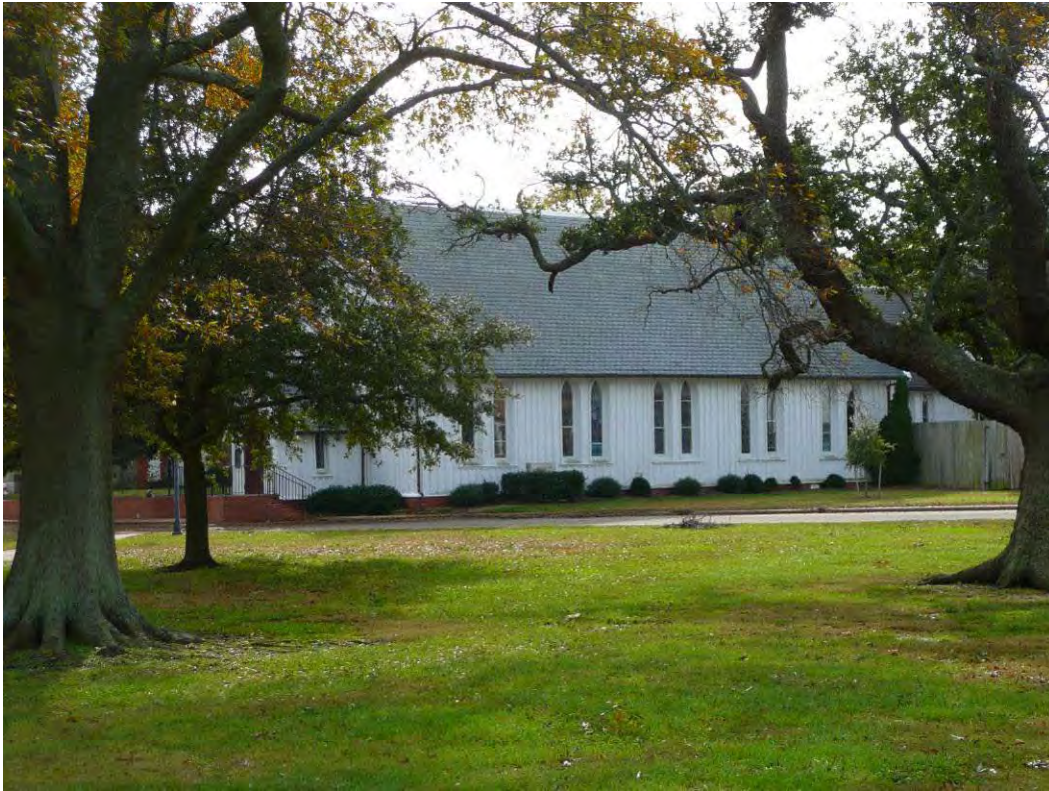
Figure 59. View from Parade Ground toward chapel, 2009.

A new brick accessibility ramp was added to the front of chapel. Over the years, foundation plantings have been added along the sides.

- Brickwork for accessibility ramp
- Missing trees
- Fence

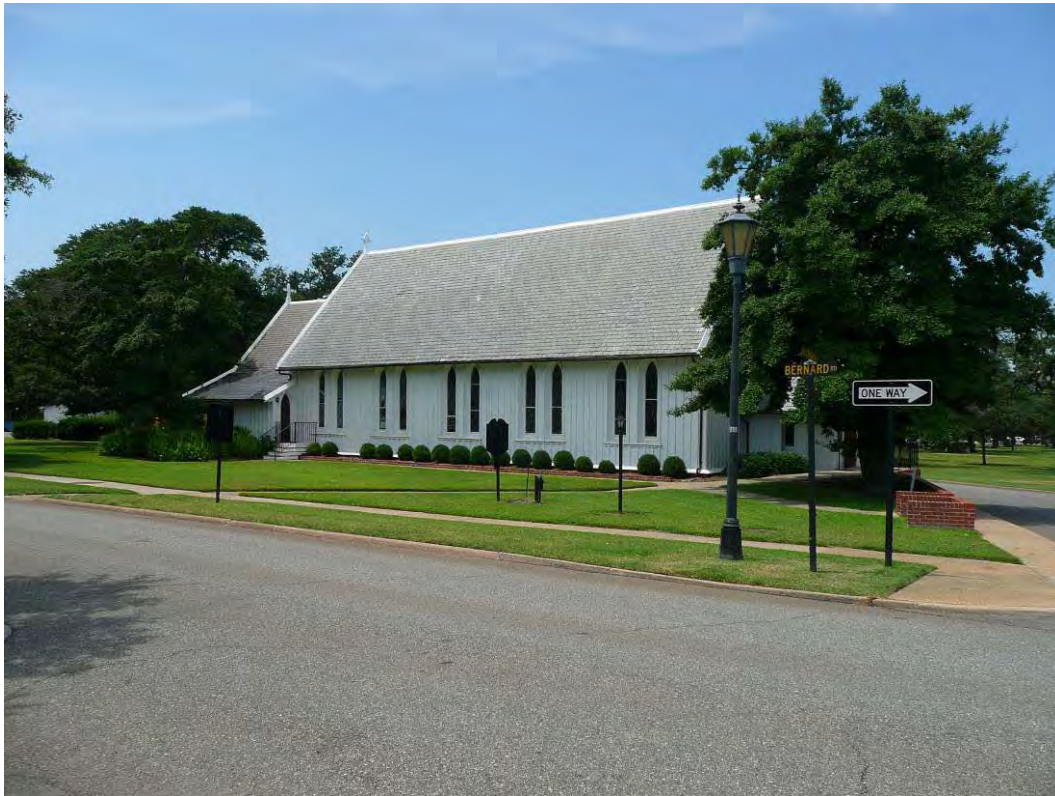
Figure 61. View north toward chapel, 2009.

The cistern is no longer present and a ramp has been added to the chapel entrance. A row of small evergreen shrubs has been added along the foundation on the south side of the chapel. Street trees are missing along Bernard Road.

- Brickwork for accessibility ramp
- Missing trees
- Signage clutter

- Consider rebuilding trophy park across from chapel
- Replant missing trees

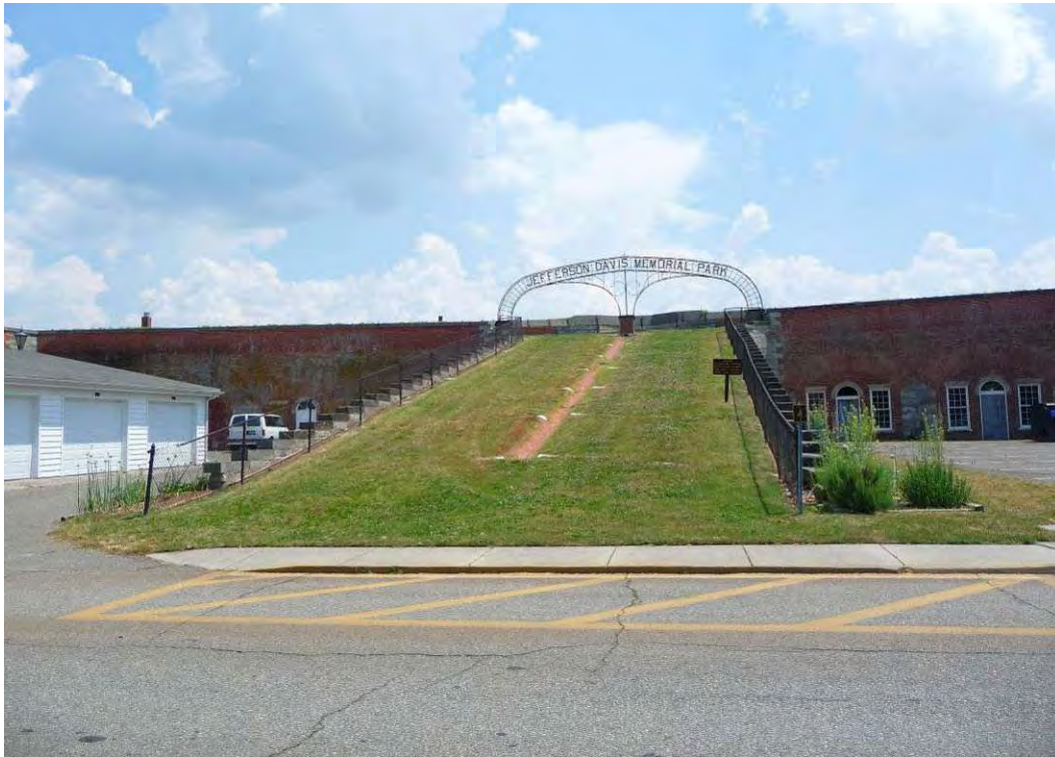
Figure 64. View toward Jefferson Davis Memorial Park, 2009.

Today the view remains the same with the exception of the addition of chain link fencing along the edges. Based on photographs, the fencing was added between 1956 and 1986. While trees and shrubs have been removed from the terreplein since 1956, these would not have existed during the period of significance of the fortification itself so this does not affect the integrity.

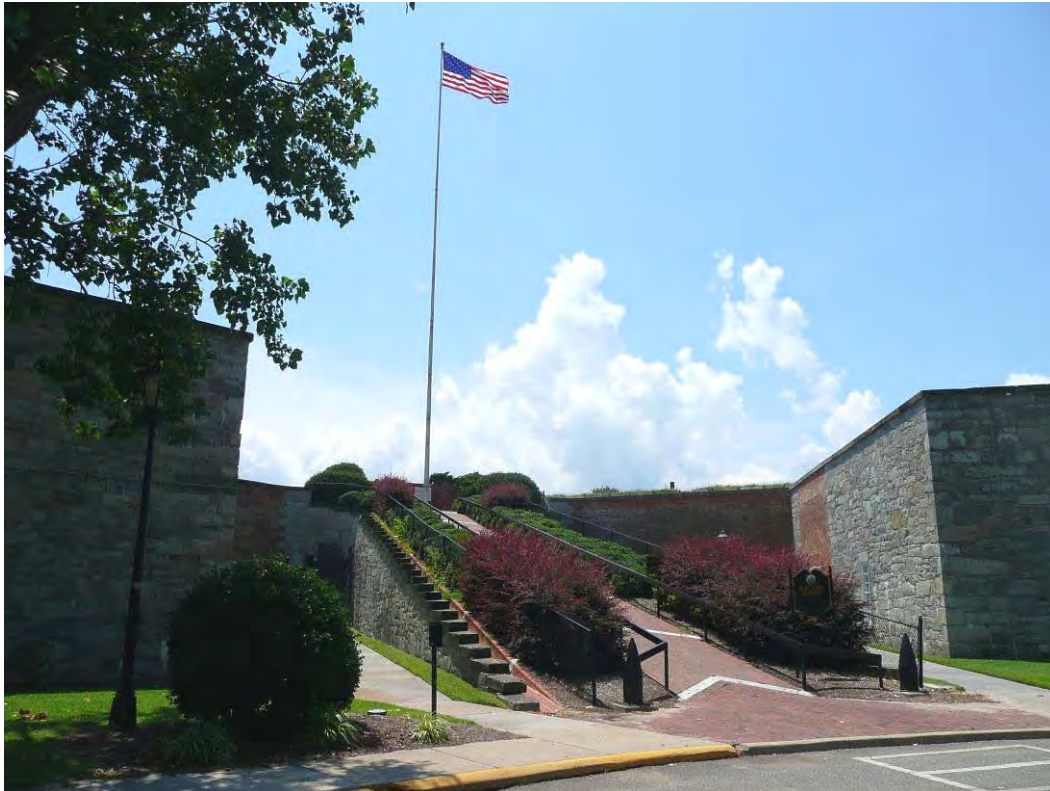
Figure 69. View of flagstaff bastion, 2009.

Landscaping and rails ascending the bastion have been added along with a brick path. The Casemate Museum is located in the casemate to the right, so museum visitors may walk up the bastion as well. Interpretive signage and some guns are located at the top as well as views out to Hampton Roads and Fort Wool.

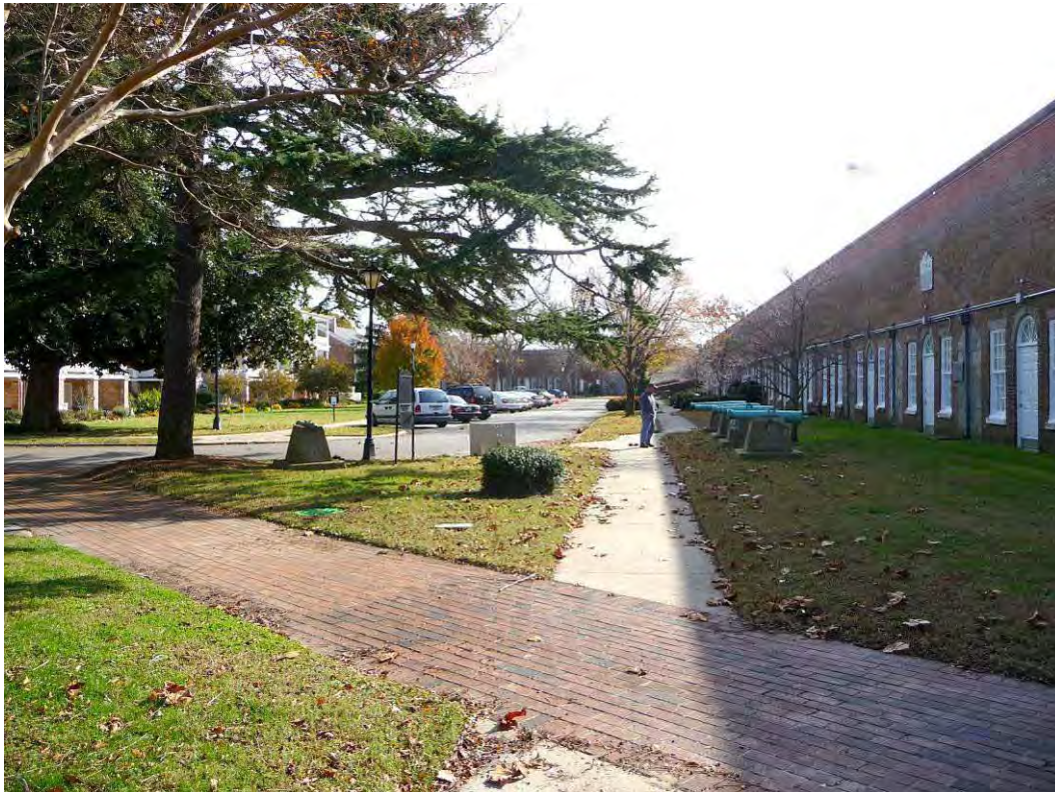
Figure 71. Tuileries and first casemate, 2009.

The Casemate Museum is now located in the casemate (Building 20). The Tuileries are used for officers' housing. Parking is located along Bernard Road for visitors to Casemate Museum. Guns, cannon balls, benches have been added in front of the museum. Signage and parking have been added for visitors' way finding and safety and do not have a major effect on integrity.

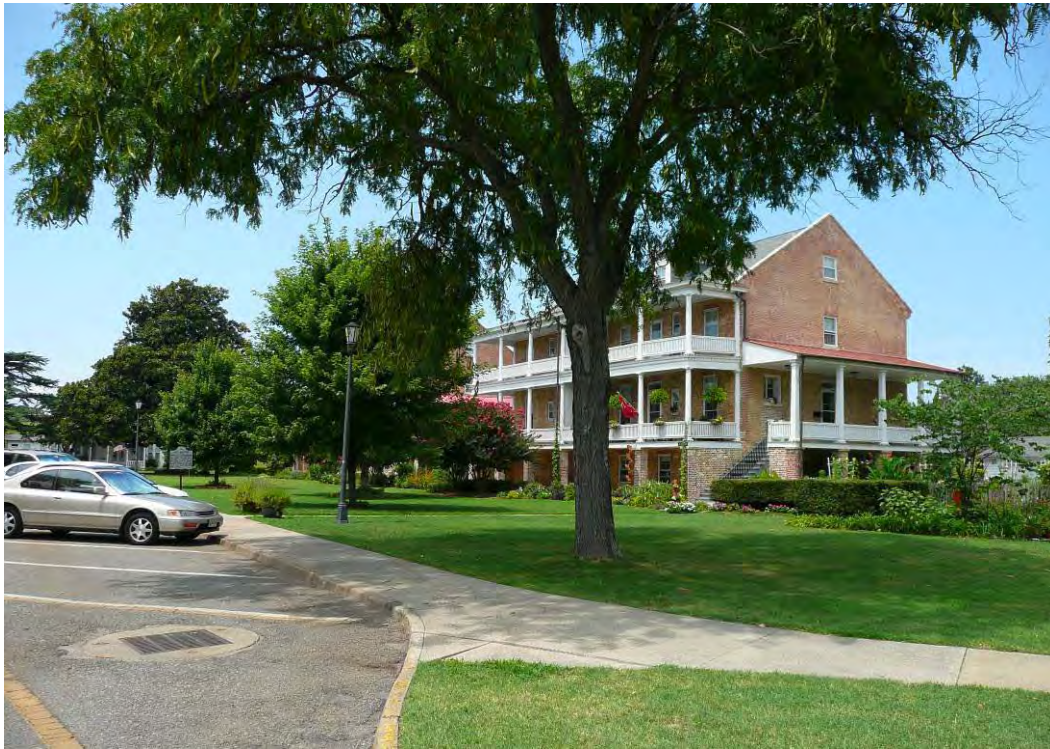
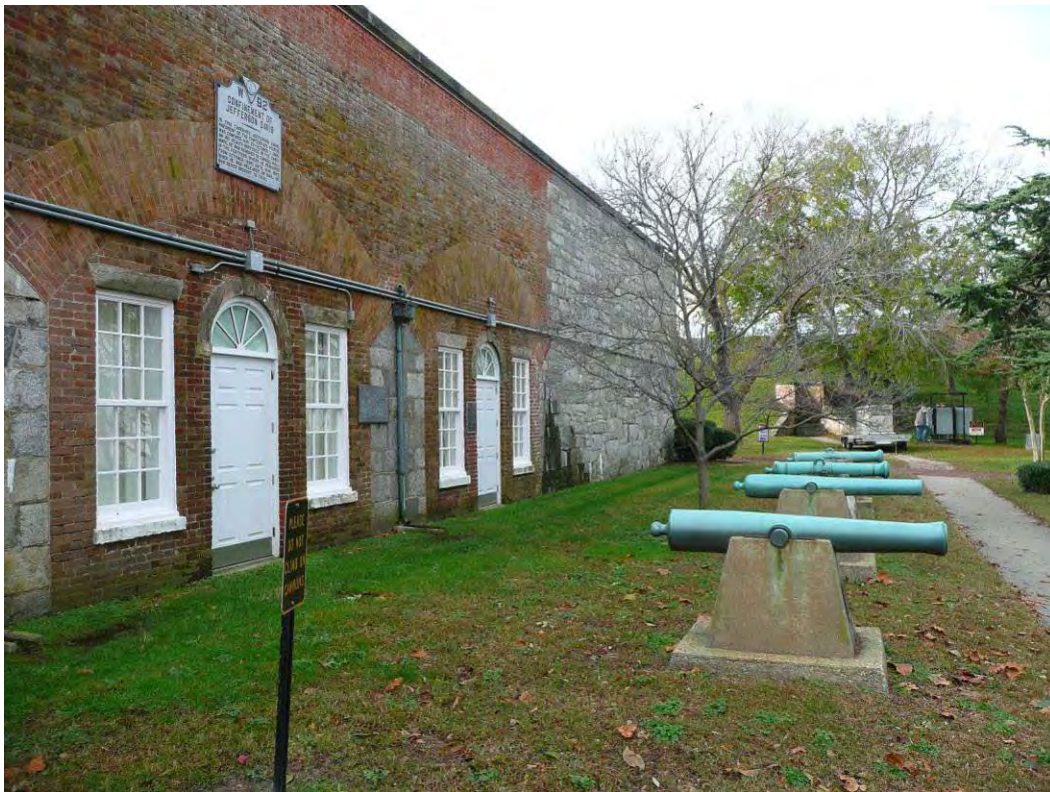
Parking for the Casemate Museum and signage has been added to the street and in the viewshed, but do not have a major effect on integrity.

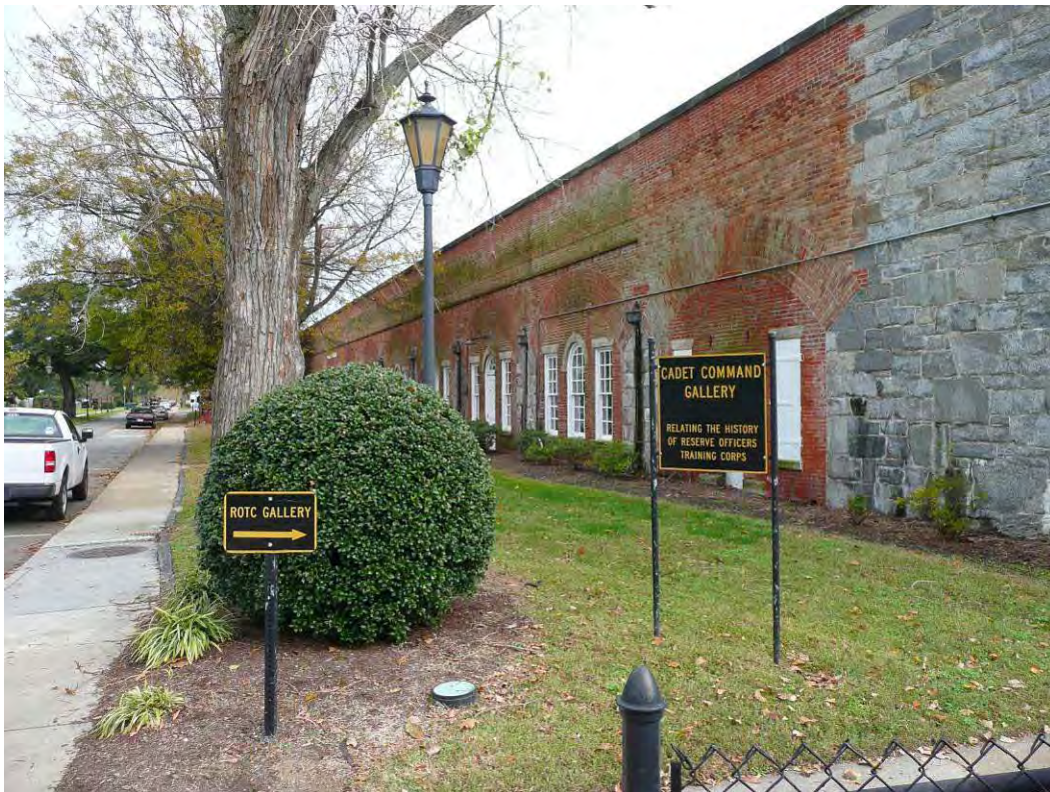
Figure 79. Casemates of the second front, 2009.

Building 21 currently serves as Chapel Center and office spaces.

- Parking along street
- Condition of casemate

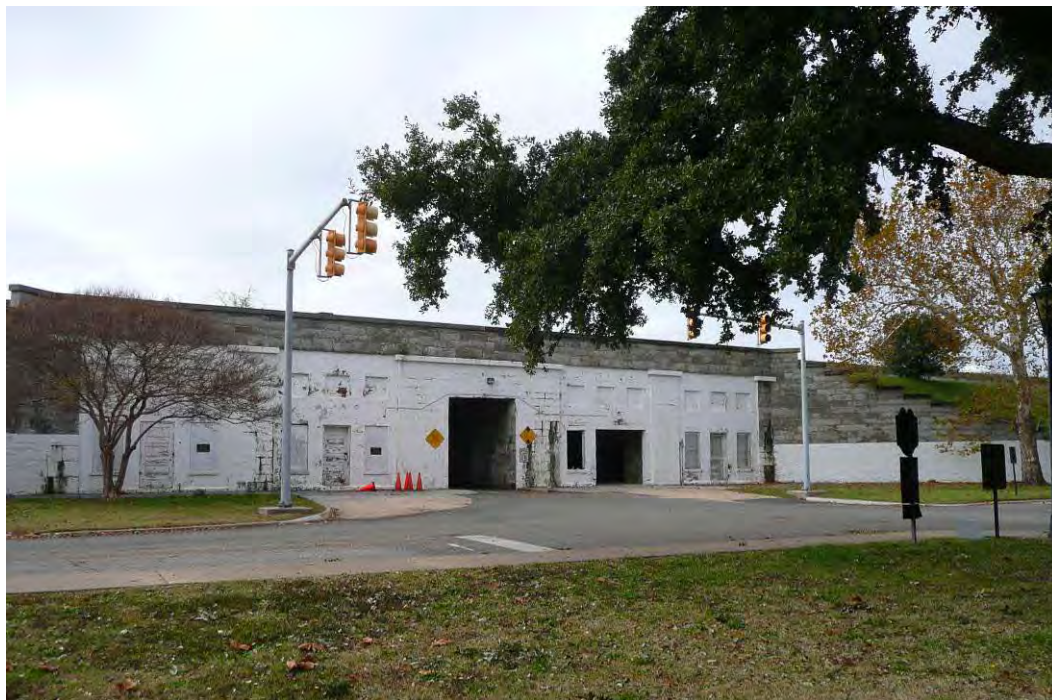
Figure 89. Guard house at main gate, 2009.

Currently used as vehicular and pedestrian passageway and storage.

- Condition of casemate
- Street lights and signage

- Remove paint
- Replace doors and window coverings

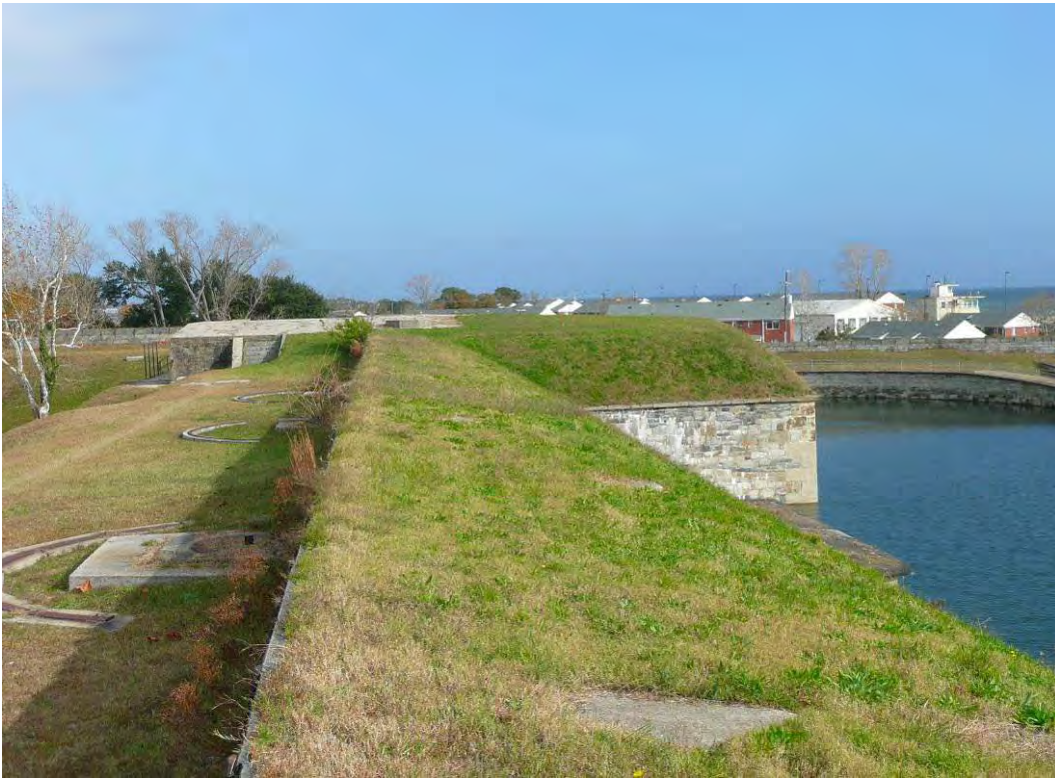
Figure 91. View northeast from fort, 2009.

Today, this area is dominated by Wherry family housing although many of the original units are missing both south and north of Battery DeRussy.

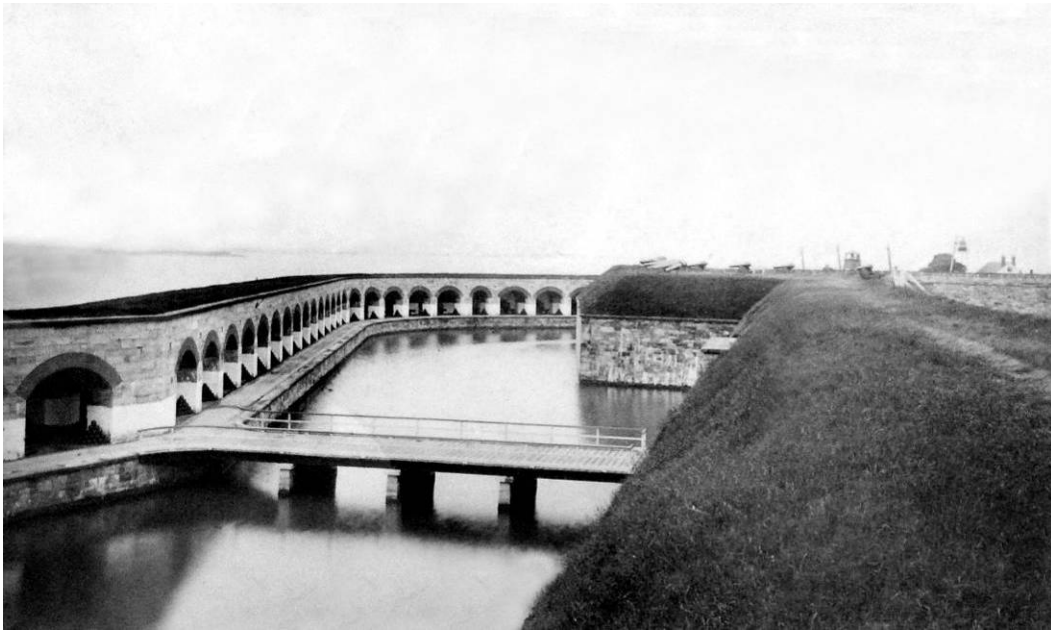
Figure 92. View south of east gate and water battery, date unknown (NARA College Park).

Water battery was constructed in 1832 to protect the seaward approach to Fort Monroe. It was deemed obsolete by the 1890s and demolished in 1907 to build Battery Parrot.

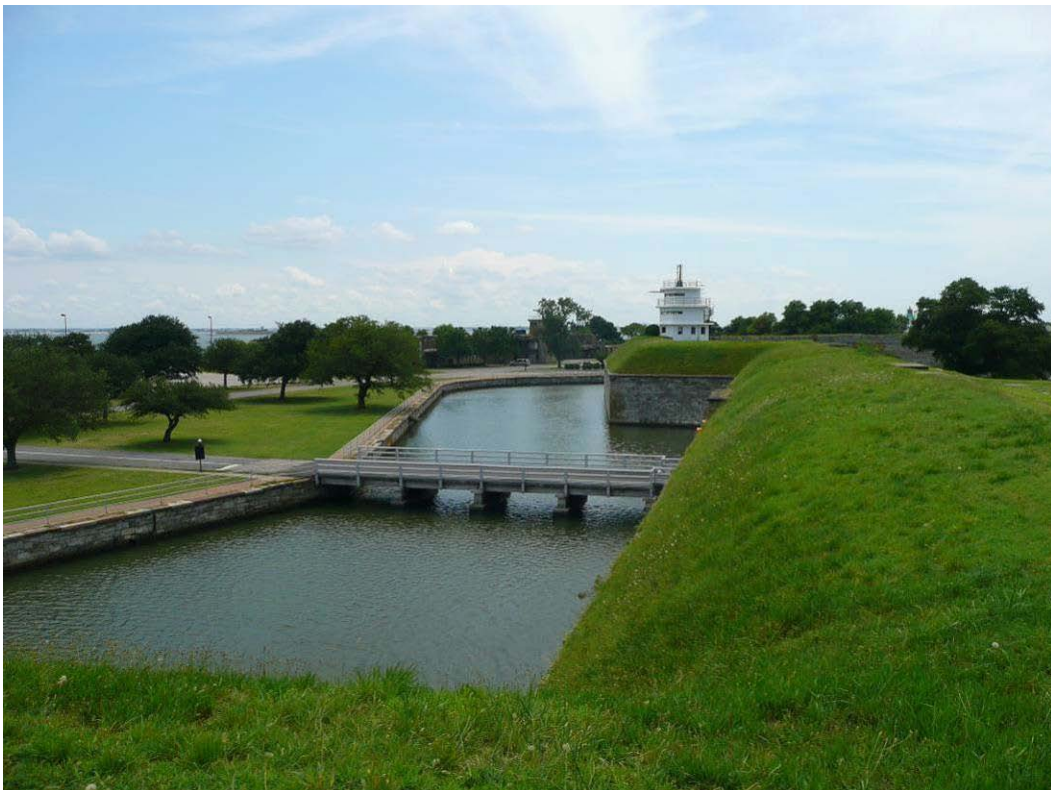
Figure 93. View south at east gate, 2009.

The water battery was demolished in 1907. Only a section of the powder room remains.

- WWII-era Military Affiliate Radio System (MARS) station
- Missing water battery

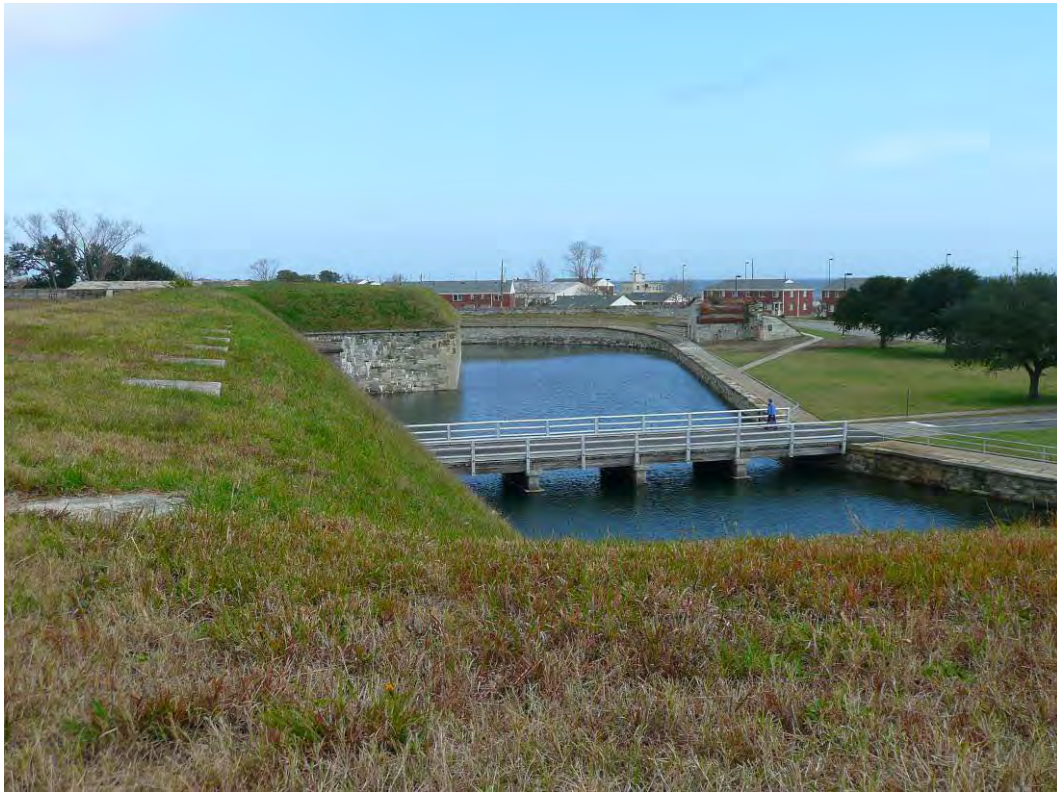
Figure 96. View north of east gate, 2009.

The only remaining section of the water battery is visible in the center of the current view. Wherry Housing was added in the 1950s.

- Wherry housing
- Missing water battery

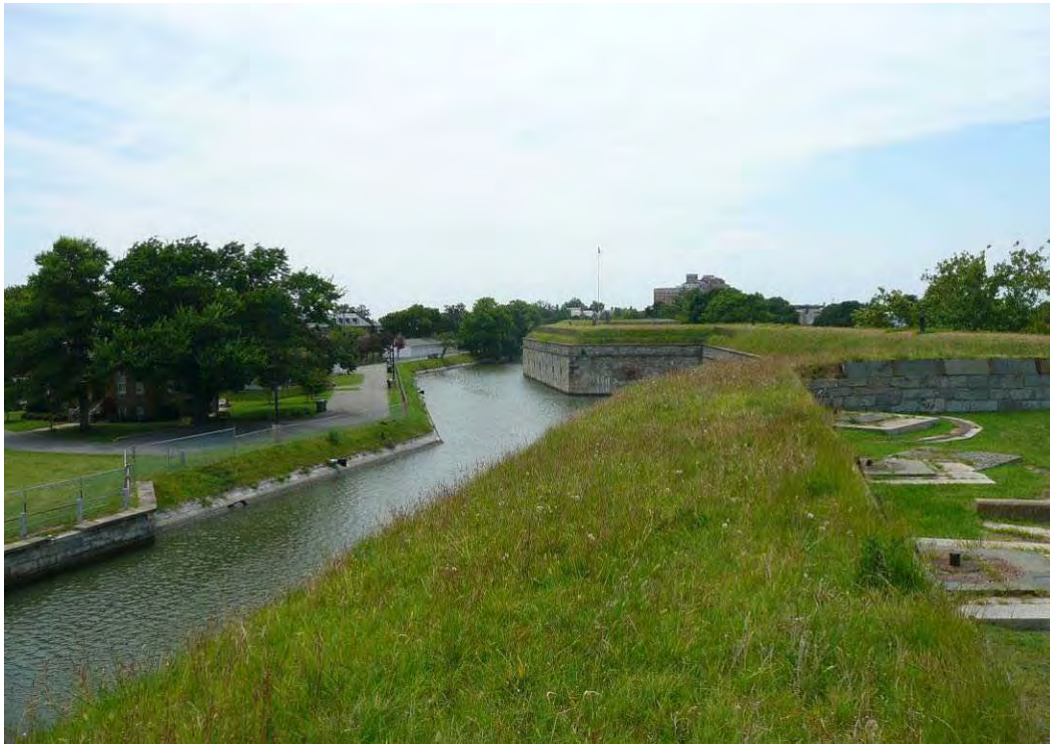
Figure 99. View southwest, 2009.

The water battery was demolished in 1907.

- Missing water battery
- Fence
- Trees block view of lighthouse and Hotel Chamberlin

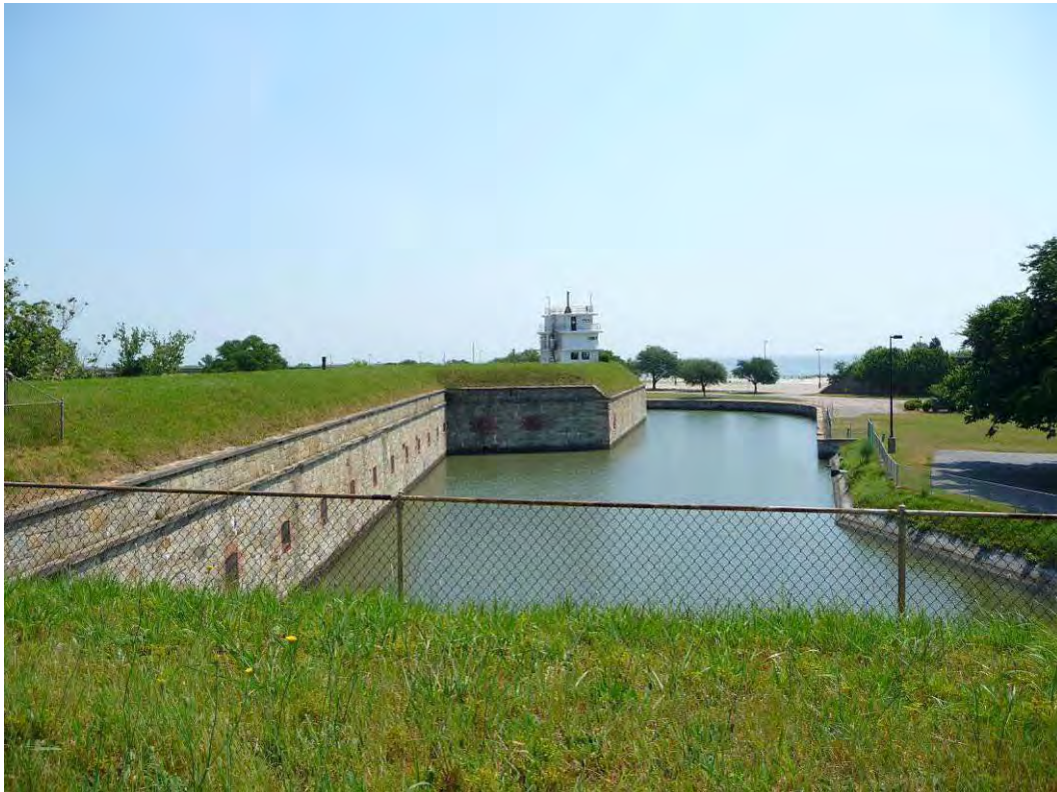
Figure 102. View east from south bastion, 2009.

In the center of this view today is the MARS station. The MARS station was built in 1943, currently used as storage and recruiting offices.

- WWII-era MARS station
- Missing water battery (which would have reduced water views)

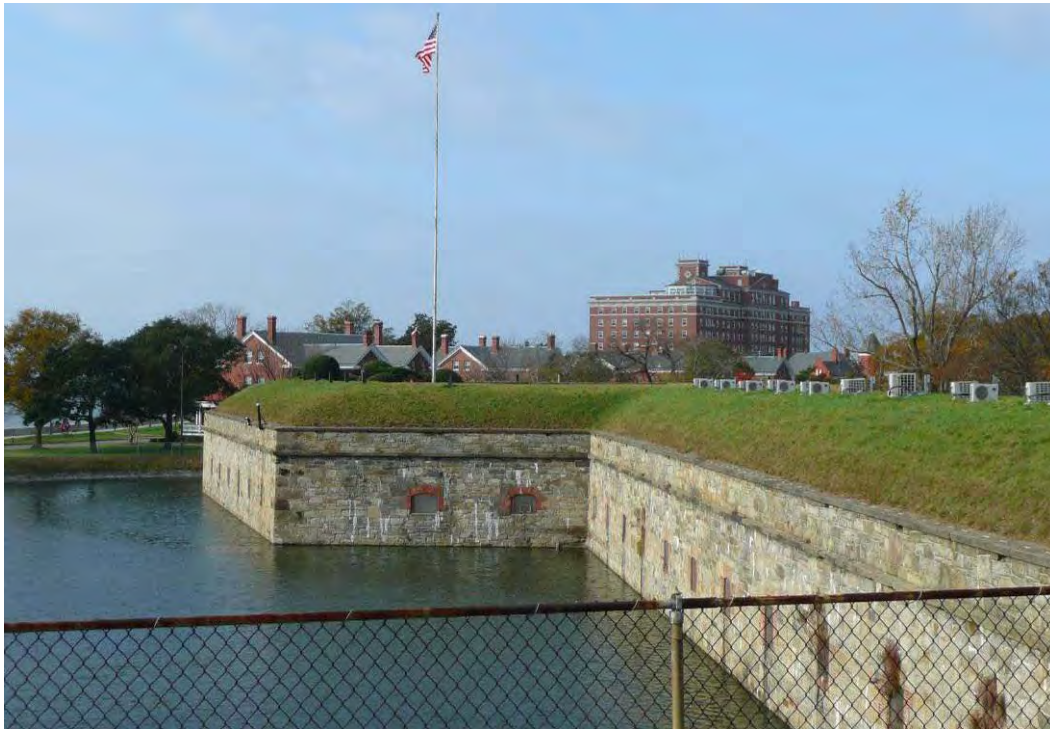
Figure 105. View toward Flagstaff Bastion, 2009.

The fort, flagstaff, moat, Hotel Chamberlin, officers' quarters and water-front are still visible in this view.

- Chain-link fence
- Air conditioning units on roof of Casemate

- Consider alternatives to chain-link fence.
- Consider alternatives to air conditioning units within view

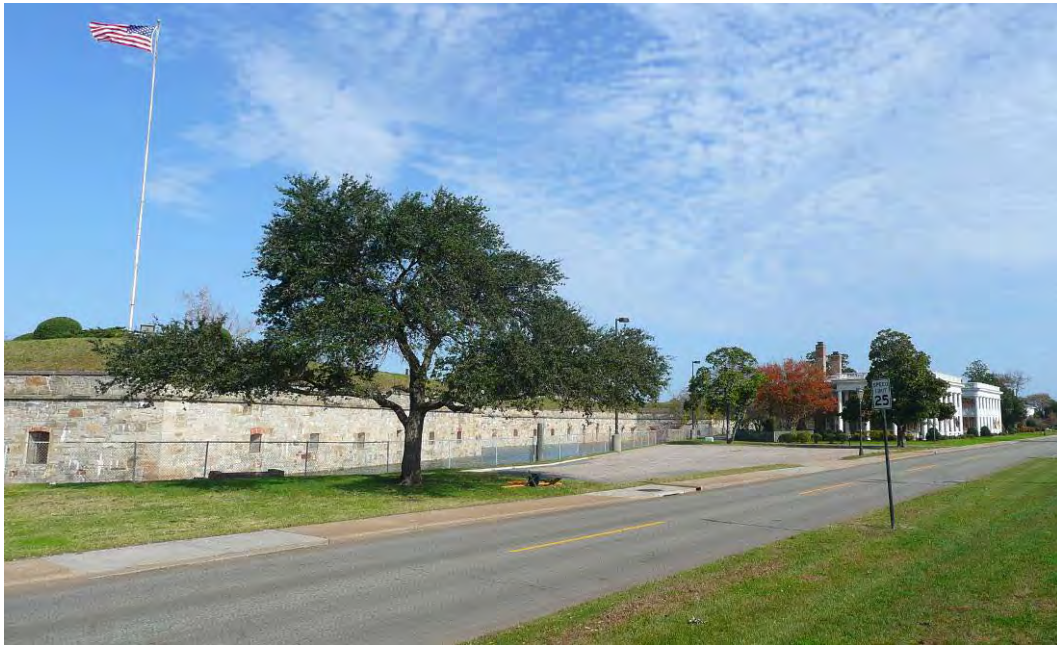
Figure 108. View east from Flagstaff Bastion, 2009.

The flagstaff, fort and moat are still highly visible in this view.
